The Handanija Mosque

Restoration/conservation of wooden boards

Restoration/conservation of the decorated wooden edge boards on the ceiling of Handanija Mosque Gallery

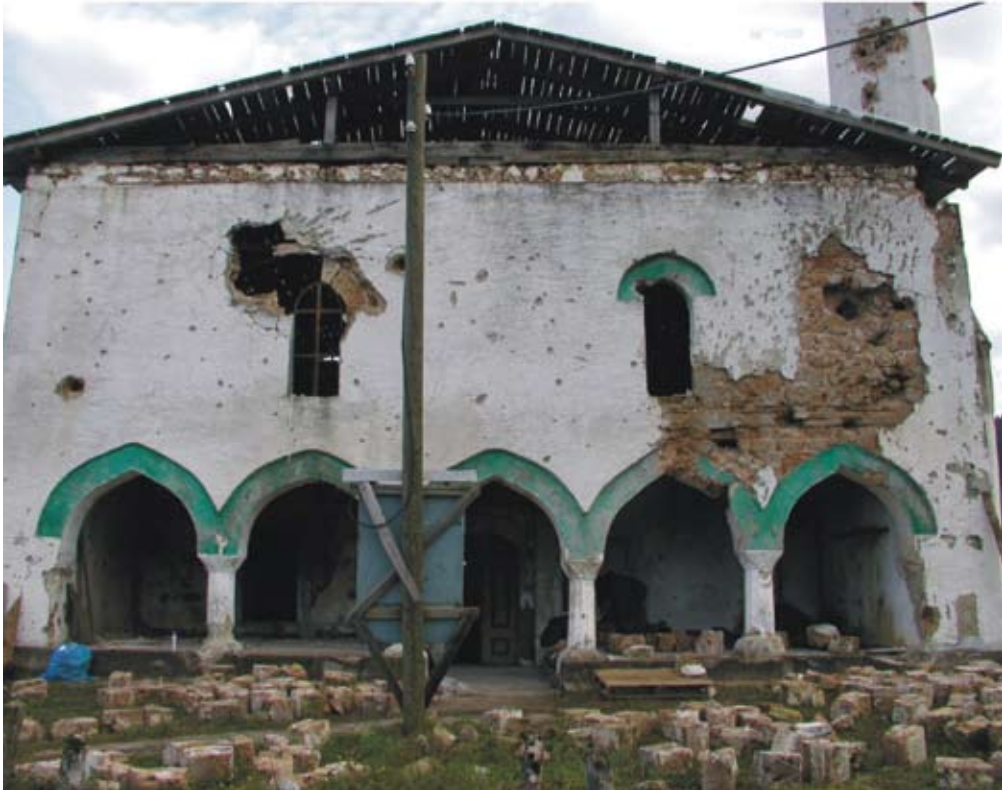
The Handanija Mosque after the destruction 1992–1995.

seven layers of stone. The Handanija Mosque was damaged during the war in 1993. Due to several direct hits, its walls, roof and minaret suffered severe damage. The roof construction was completely destroyed, while the rest of the structure was partially damaged.

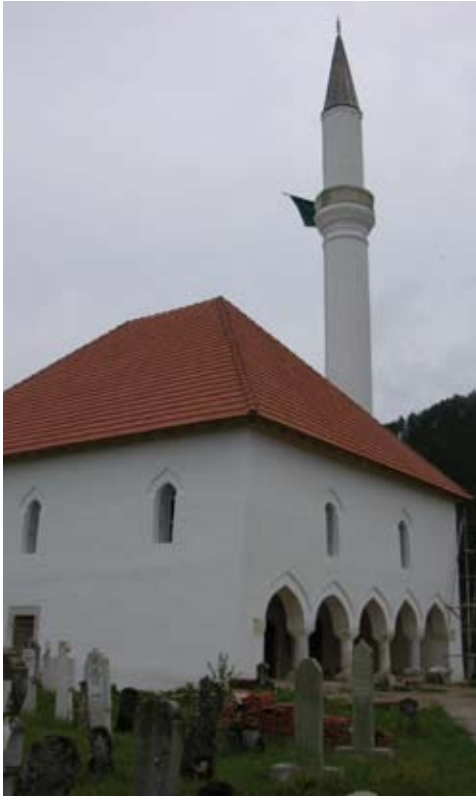
The Handanija Mosque after the restoration, 2005.

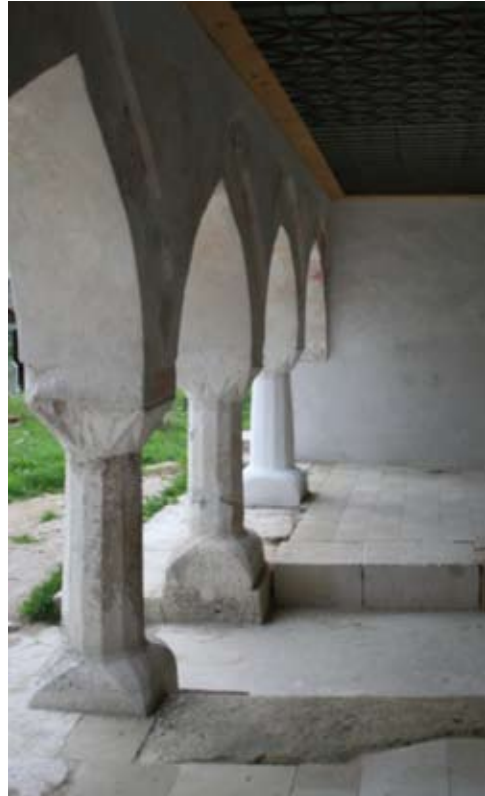
The entrance porch to the Mosque.

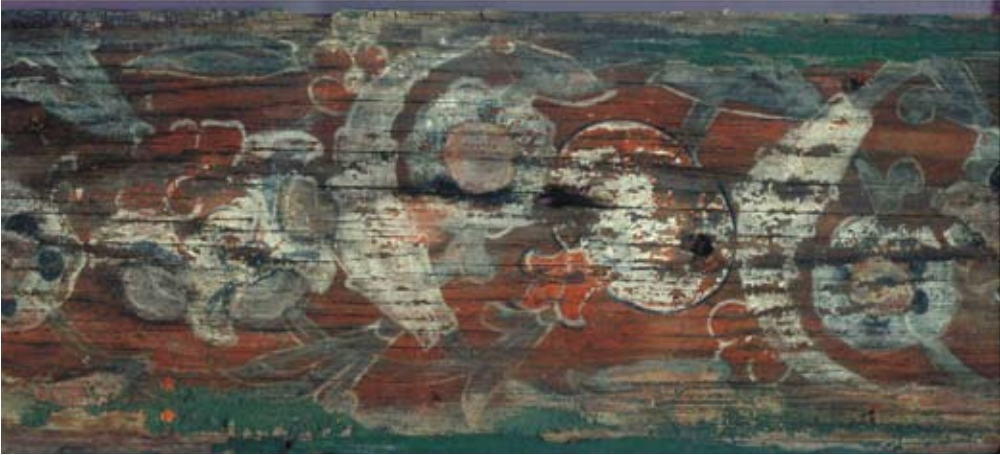
The original board with the several layers of intervention.

On the reverse side of some of the boards, there are traces of burning, while the decorated surface was treated several times with different chromatics as a part of the regular maintenance of the interior. One of the pigments found while cleaning was a bright yellow on the flowers, while heavy alkyd red paint was found filling the background of the drawing. Beside this, the edges were painted carelessly with layers of green paint which was used in previous restoration works in the interior of the mosque.

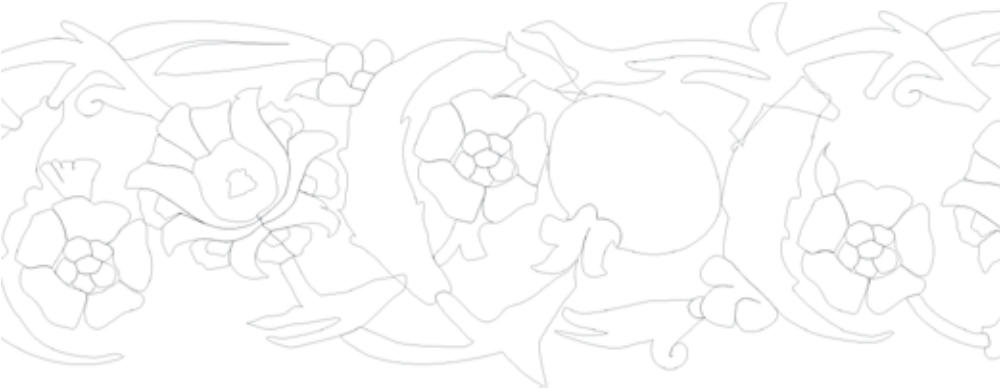
The drawing of the decoration.

While working on the drawings, the ambition has been to do so in the same manner as the old master, with composed improvised and spontaneous moves, where elements of the drawing fill the space.

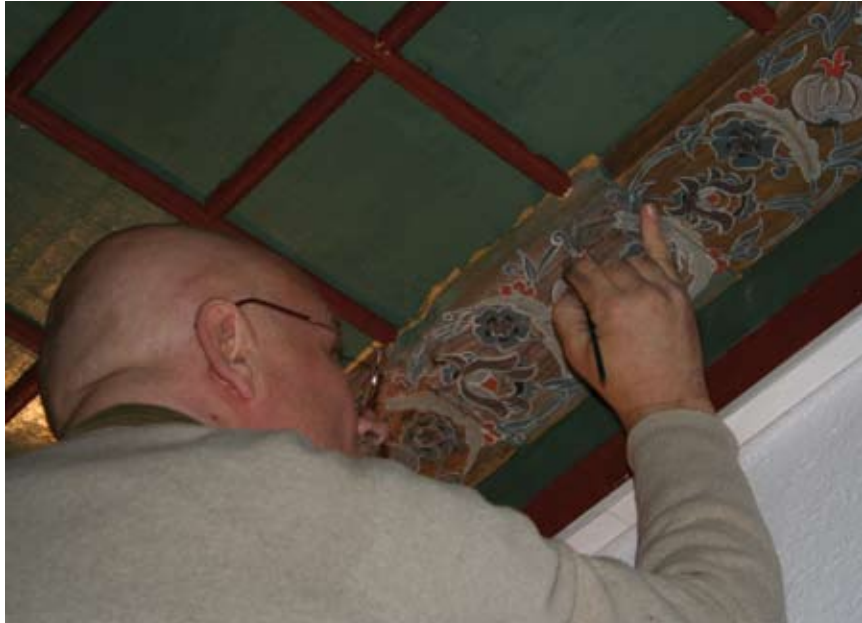
The boards were suffering from cracks, and some of the wood-knots had fallen

from their original positions. The treatment of wood-knots was originally done using a piece of paper, that was glued on from the top of the knot in order to get a smooth and even equal paint surface (as knots are darker than the wood itself), With a combined chemical and mechanical cleaning technique the green paint from the edges was removed, while the surface dirt was removed with light ammonia solution. Some of the boards were damaged in a way that the pieces of wood were attached to the old boards.

weak, it had not lost its structural flexibility, and therefore inserting wooden pieces and filling the cracks proved to be a suitable way of structural repair. The use of synthetic micro consolidation was avoided entirely.

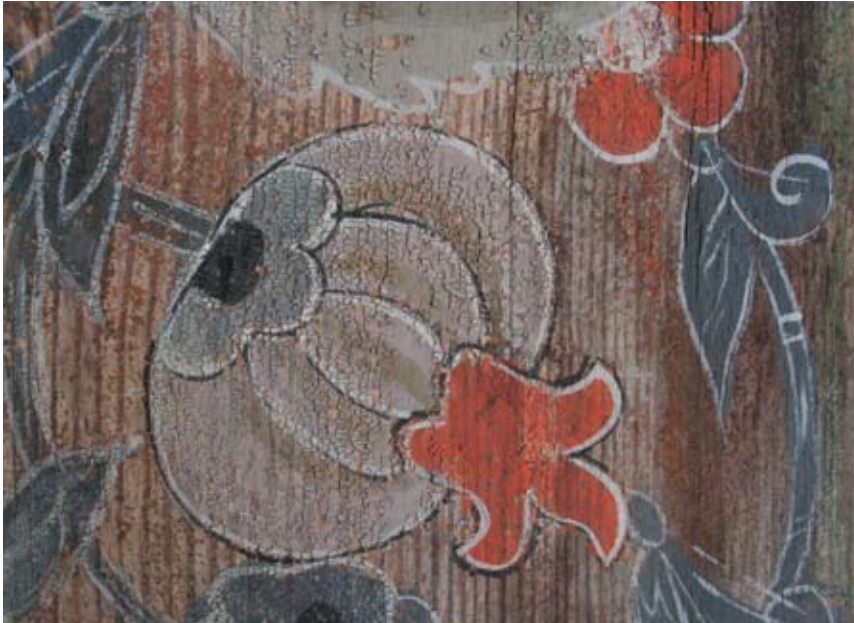
The new and authentic paint, a detail.

The colour range of tempera for recon-

struction is identical to the authentic colour range.

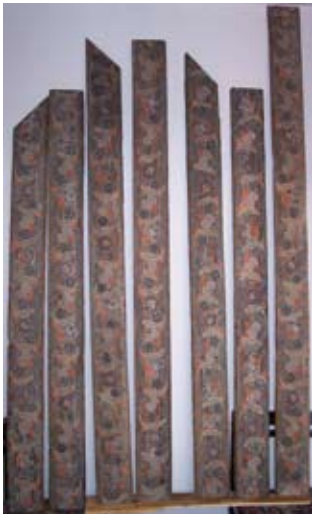
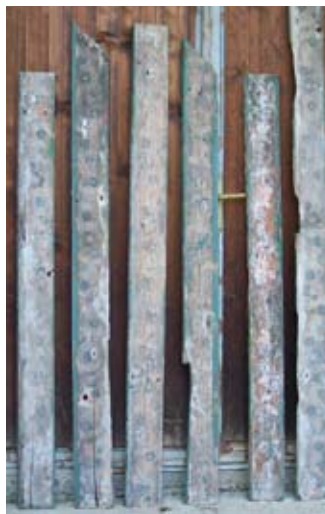
The restored authentic boards (left). Authentic boards before restoration (right).

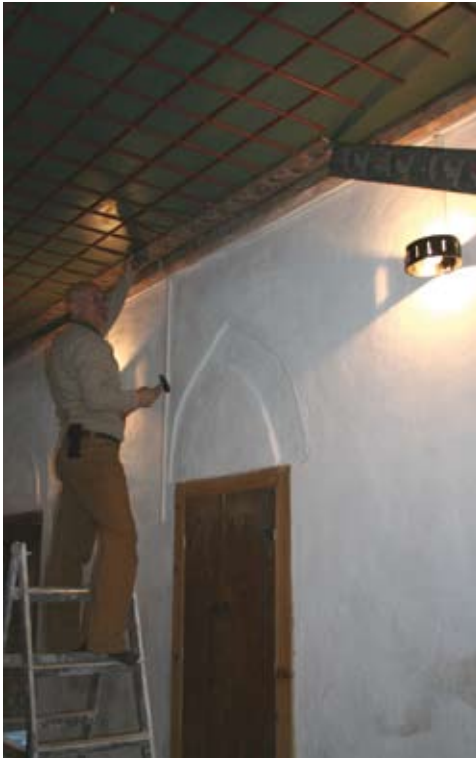
The iron nails from 17th century used when mantling the boards.

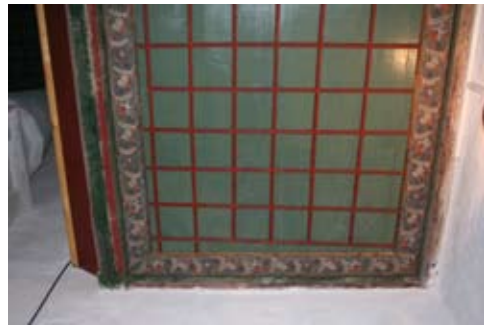
The final outcome.

With the works completed, the aesthetic function of the ceiling of the mahvil (gallery) in Handanija Mosque has been achieved once again.
