Beskrivning av KuG:s restaureringsprinciper

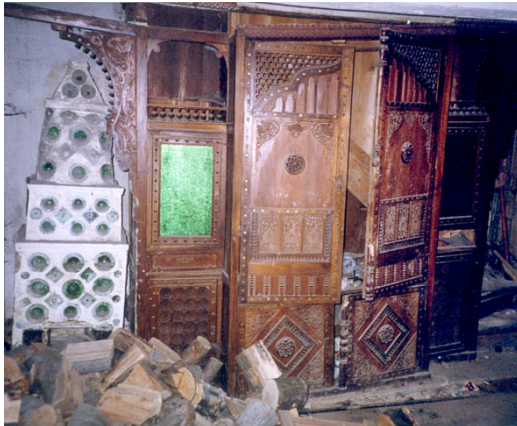
Den vita kakelugnen och den mörka träinredningen hör till traditionell bosnisk inredning. Rum på nedervåningen. Foto Pål Anders Stensson, november 1999.

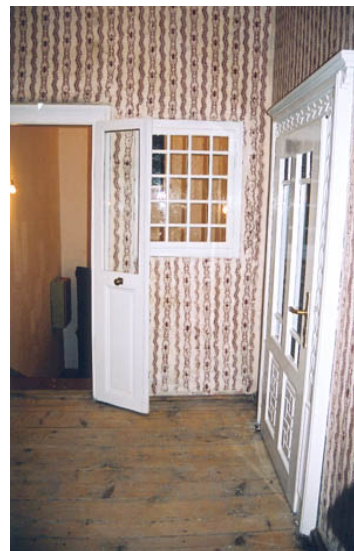
Rum på övervåningen efter restaurering. Foto Susanne Wik, december 2001.

Respecting the heritage, regardless of when it dates from, a principle that CHwB propagates in its work, can be best seen in the preservation of existing elements, even when they are relatively recent, such as plastered walls on the upper floor, which for a certain time was regarded as an important part of our heritage in Bosnia-Herzegovina.
